Santa Cruz Port District Westside Seawall Replacement Condition Assessment and Preliminary Engineering

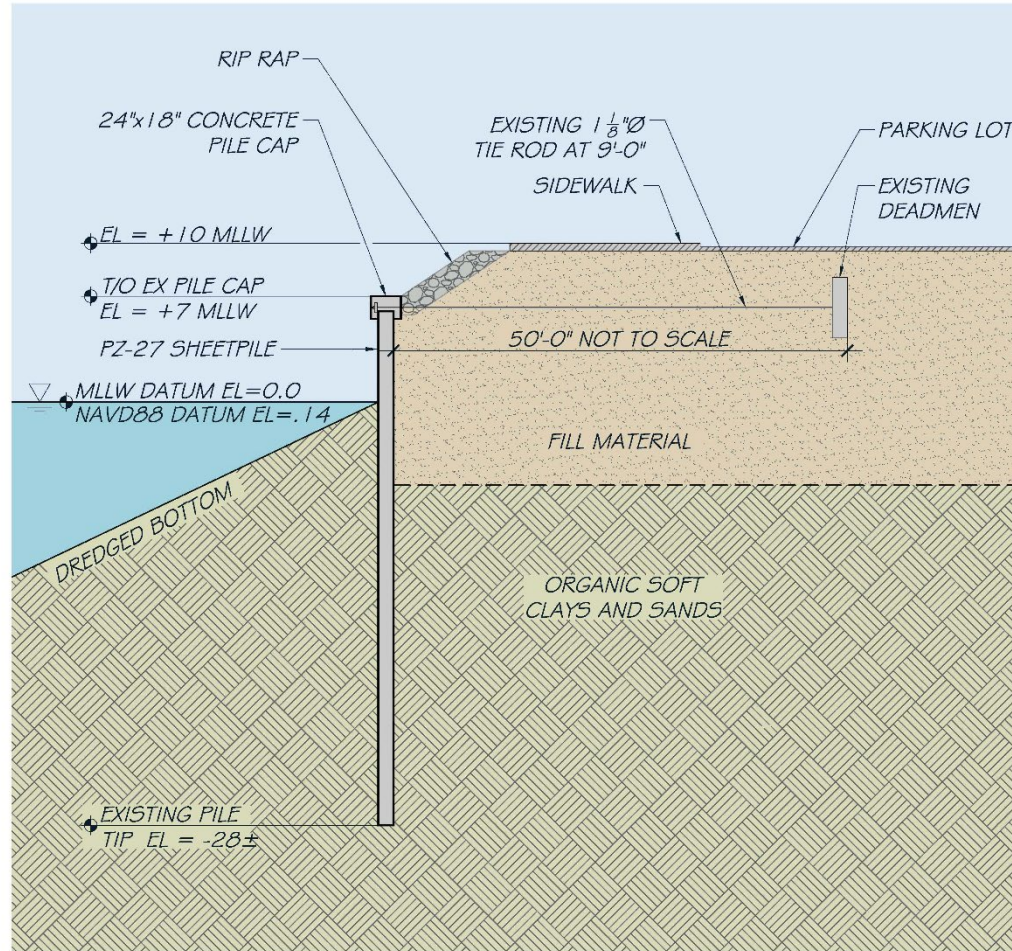
Figure 1 - Existing Seawall Section

The seawall consists of a row of sheet piles topped with a cast-in-place reinforced concrete cap beam (pile cap). The sheet piles are restrained by steel tie rods spaced at 9 feet on-center. The steel tie rods connect the seawall to buried concrete panels (deadmen) located a distance 50 feet behind the sheet pile wall.

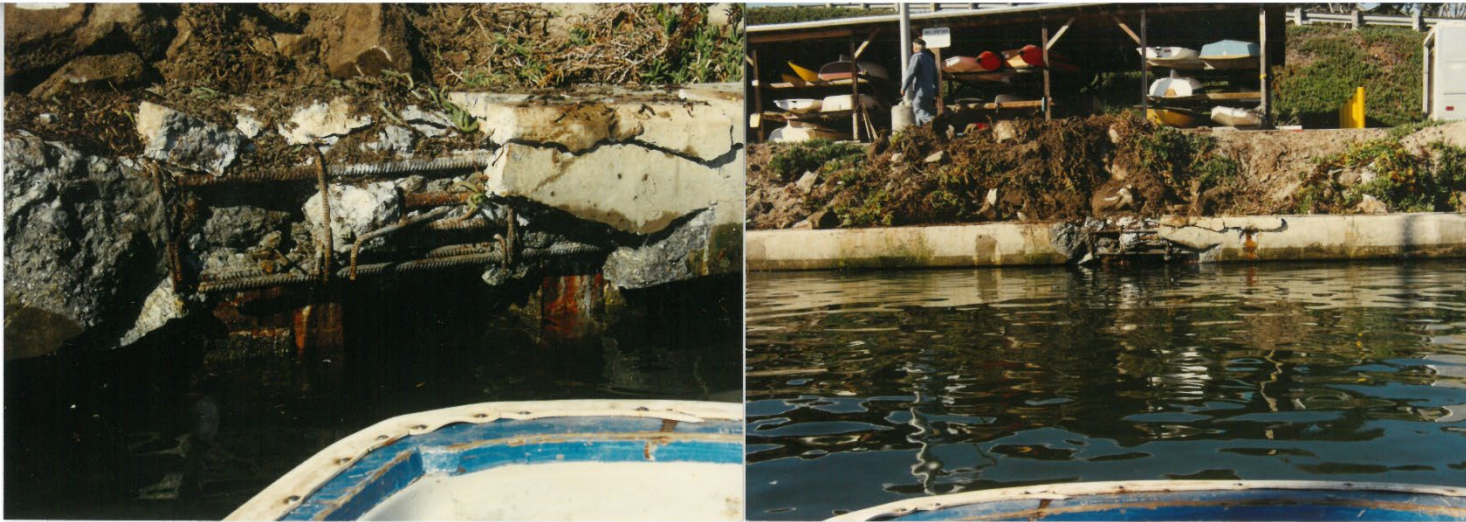
Condition: Varies, Moderate to Severely Deteriorated

- Condition varies from completely undamaged with no evidence of corrosion or spalling (almost like new condition) to significantly damaged with numerous cracks, splits and spalls.
- Pile cap was seriously damaged by the Loma Prieta earthquake of 1989
- Rust stains are visible which indicates the reinforcing steel is corroding
